### CIVIL AERONAUTICS BOARD

# ACCIDENT INVESTIGATION REPORT

## TRANSOCEAN AIR LINES, INC., SHANNON, IRELAND, AUGUST 15, 1949

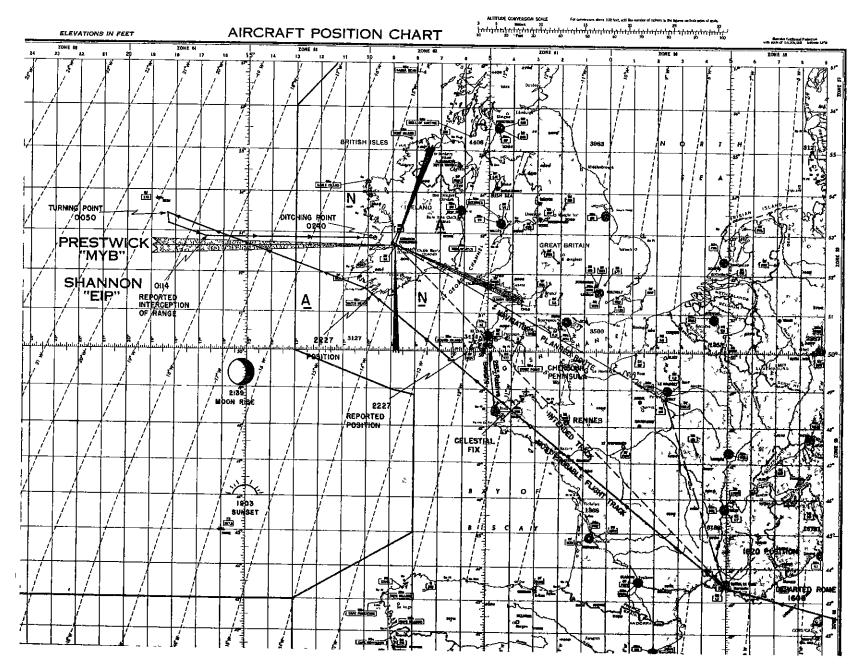
daylight of August 15, 1949 Seven passengers and one crew member died as a result of exposure or drowning, all others were successfully rescued (See chart Appendix I for flight path)

No reliable estimate of air speed from the southern tip of Ireland to the turning point, the point where the flight began its return to Shannon, can be made because power was reduced after 0010 and the crew had no recollection of either power settings or air Accordingly, only a general area in which the turn was made can be established On the basis of fuel consumption which was actually in excess of 200 gallons per hour for the entire period of the flight, it would appear that the air speed could not have been less than 160 knots, taking into full consideration a reduction of power after 0010 as testified to by the crew With this estimate of minimum air speed and the winds that existed at the time, the flight would have had a ground speed of 152 knots from Mizen Head and would have flown a distance of 324 miles before turning for return to Shannon sidering winds, the heading of 310 degrees which the crew stated they flew, and a possible steering error for the flight consistently tended to fly left of course, it appears that the most likely track from Mizen Head was approximately 310 degrees magnetic The turning point, therefore, would be about 324 miles from Mizen Head on a magnetic bearing of 310 degrees, or in the general location of 53 27 degrees north latitude and 18 20 degrees west longitude (See Chart, Appendix I )

In summary, it appears that the most probable flight track was from Rome to Marseille, from Marseille to Mizen Head, from Mizen Head to the turning point of 53 27 degrees north latitude and 18 20 degrees west longitude, and from there to the point of ditching
